# PRODUCT SAFETY

## ADVISORY

**PRODUCTS AFFECTED:** FJ175

**PART NUMBER(s):** FJ175 Aluminum Floor Jack that were built prior to week 48 of 2019. This is noted by serial number range up to 1948J000.

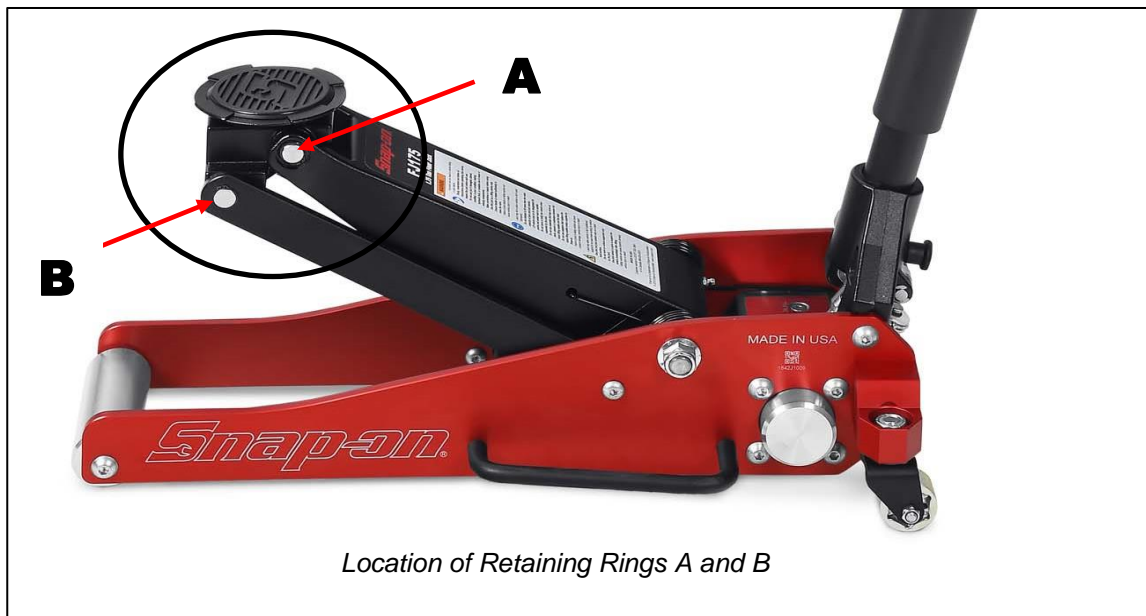
**ACTIONS:** Inspect the retaining rings to ensure they are intact and fully seated in the pin grooves. Inspect each of the four locations as shown. If any of the retaining rings noted as 'Not OK' on page 2 and 3 of this advisory, order FJ175RRKIT Retaining Ring and Pivot Pin Replacement Kit. The kit contains one Pivot Pin (B) and four Retaining Rings. Pin A does not need to be replaced. Note the FJ175KIT is Lifetime Warranty. Return the original Pin B and Retaining Rings to the RPC for full credit.

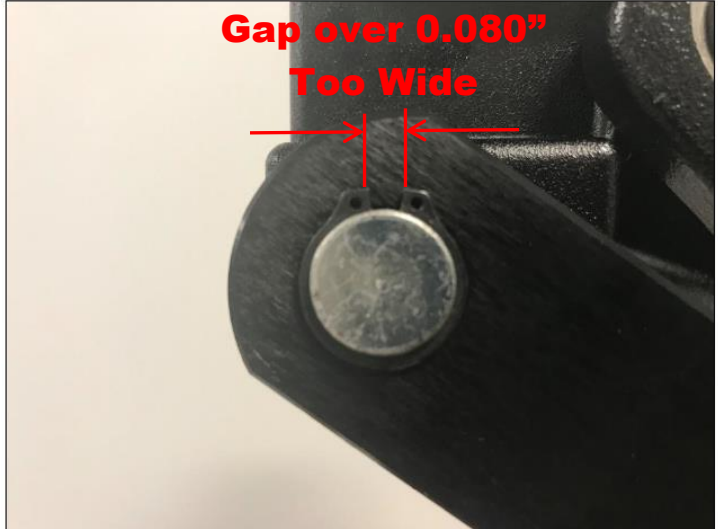
**Not OK**

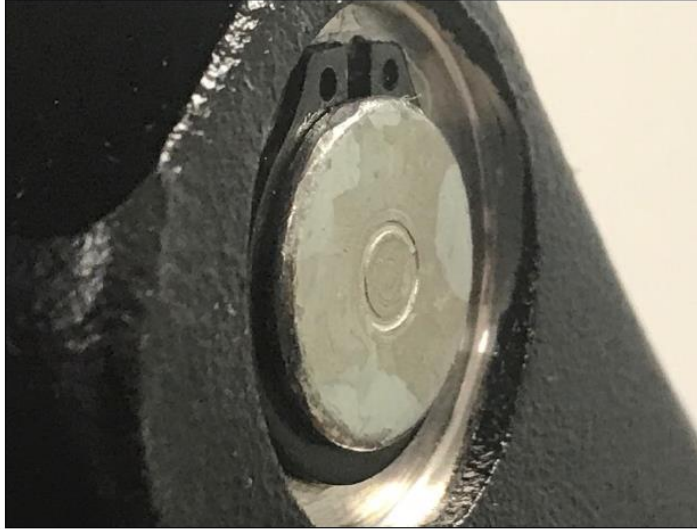
**OK**

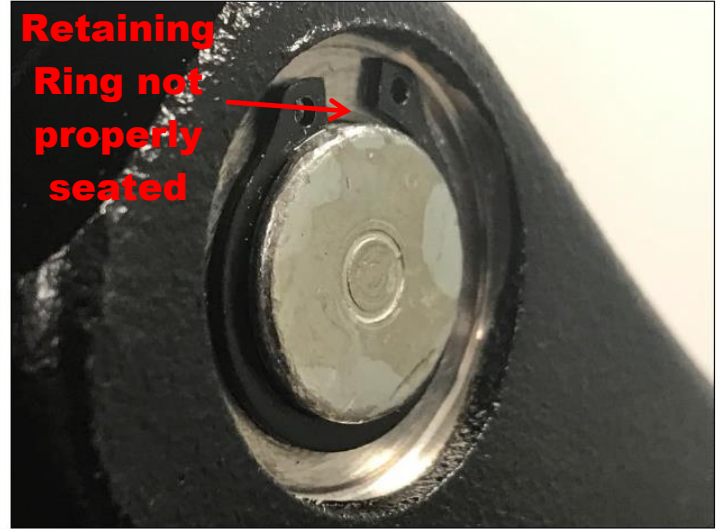
**Not OK**

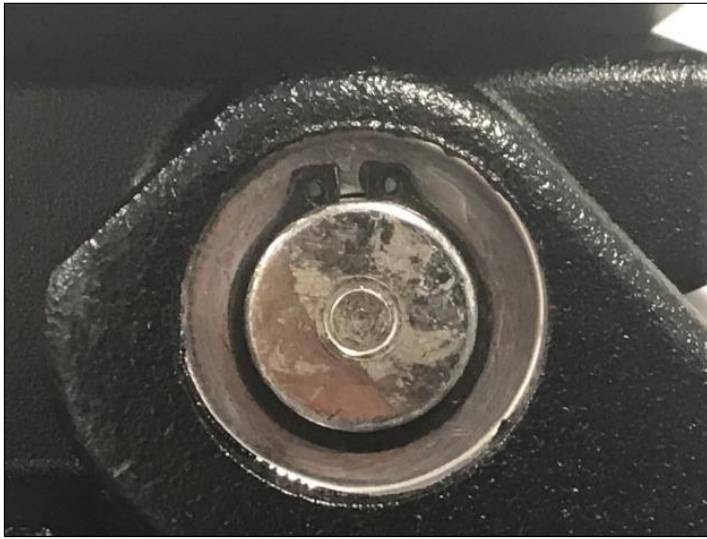
**OK**

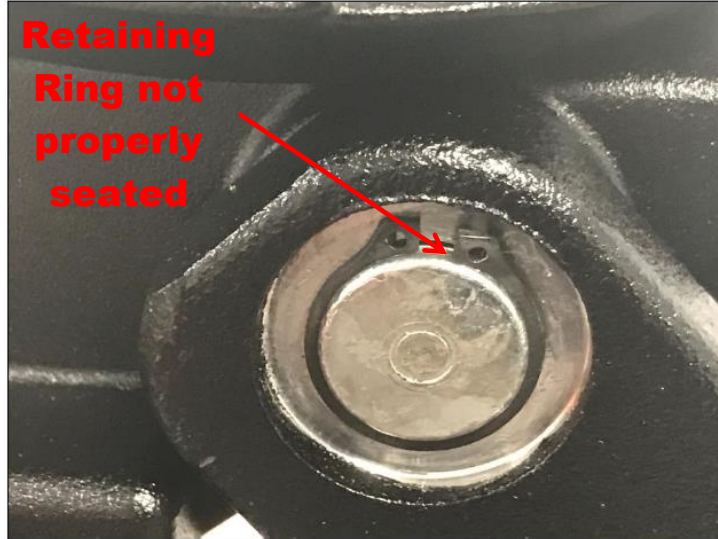
**Not OK**

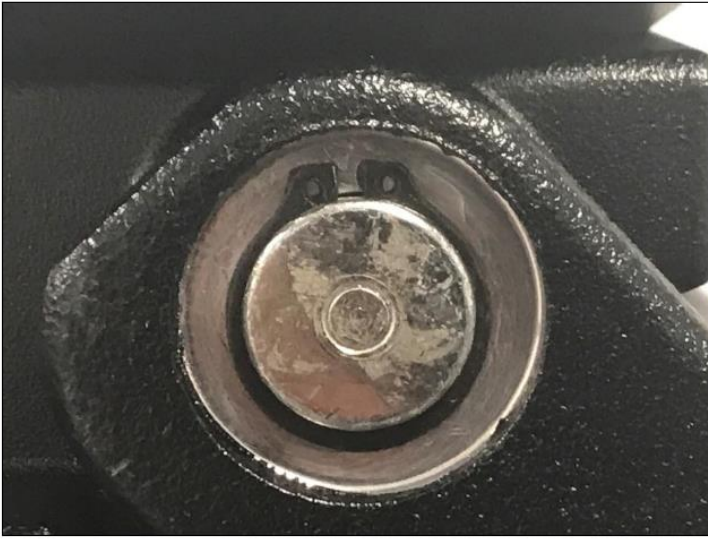
**OK**

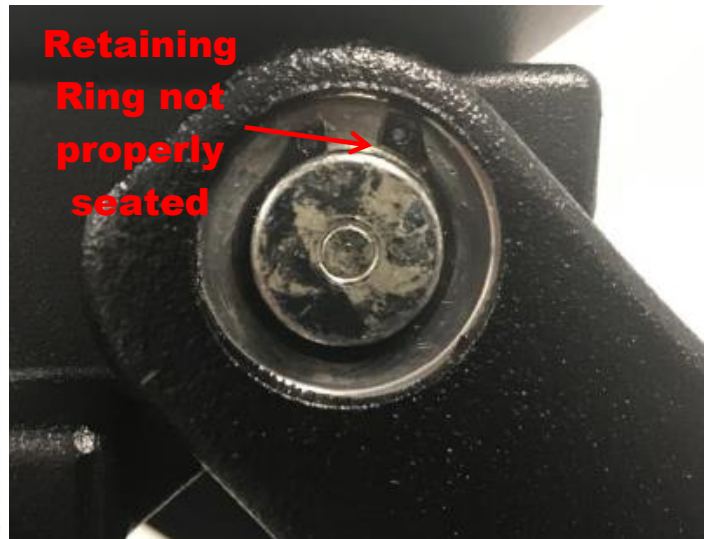
**Not OK**

Note: it is not necessary to orient the snap ring with the tangs up.
