# PRODUCT SAFETY

## ADVISORY

**PART NUMBER(s):** FJ200 2-Ton Floor Jack, FJ300 3-Ton Floor Jack

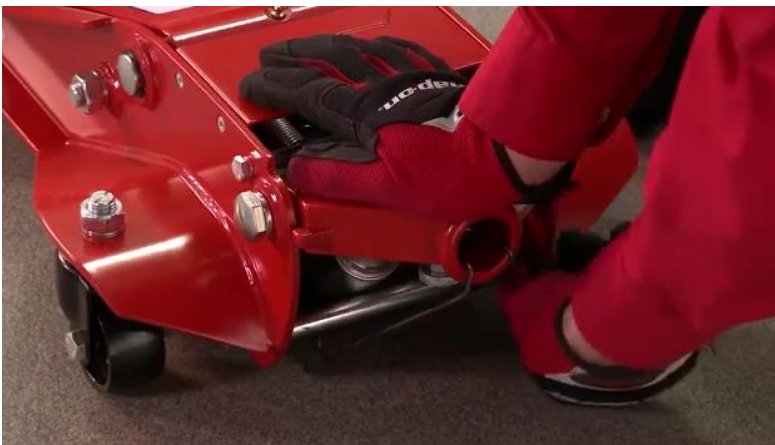
**HAZARD:** When unpacking the FJ200, the yoke clip may have a sharp edge and could potentially cause an injury.

*Wear gloves when removing yoke clip*

**ACTIONS:** Wear gloves when removing yoke clip. For proper procedure to remove the yoke clip, consult the Quick Start Guide, Owner's Manual or scan the QR code below for proper procedures.

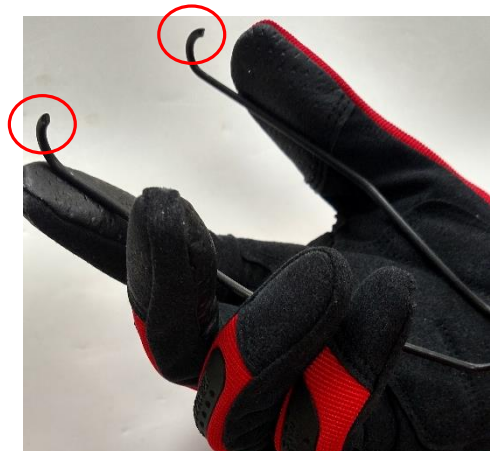
*Red circled areas indicate the potential hazard if proper procedure is not followed.*
