PRODUCT SAFETY

Snap-on Incorporated

ADVISORY -- FOR REPAIR

Repair of 1/4 "drive Ratchet

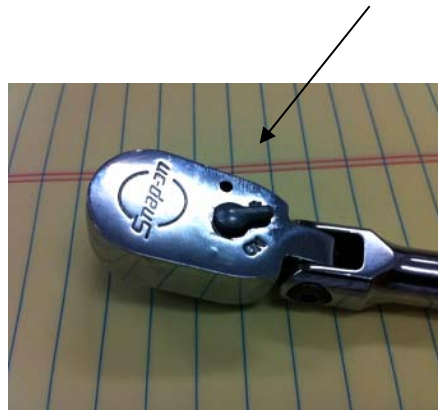
Risk of serious personal injury to your hand could occur if you hold the ratchet head in your hand when applying final torque to ratchet screws during ratchet repairs. In those cases where the screw holes are drilled too deep, any foreign objects in one of those screw holes could break through the back of the ratchet housing.

Do not place hand on backside of ratchet when applying final torque to ratchet screws during ratchet repair. Place ratchet on a hard surface or hold in vise during final tightening. Be sure that the screw hole is free of any ball or obstructions.

If you encounter any of these ratchets where there is a break through the back of the ratchet housing, return the ratchet for full warranty.
